UI Bulletin #111

Subject: **Auxiliary Power Connections**

Models: Chevrolet Caprice PPV (w SEO K5S-auxiliary battery)

Model Years: 2011-2014

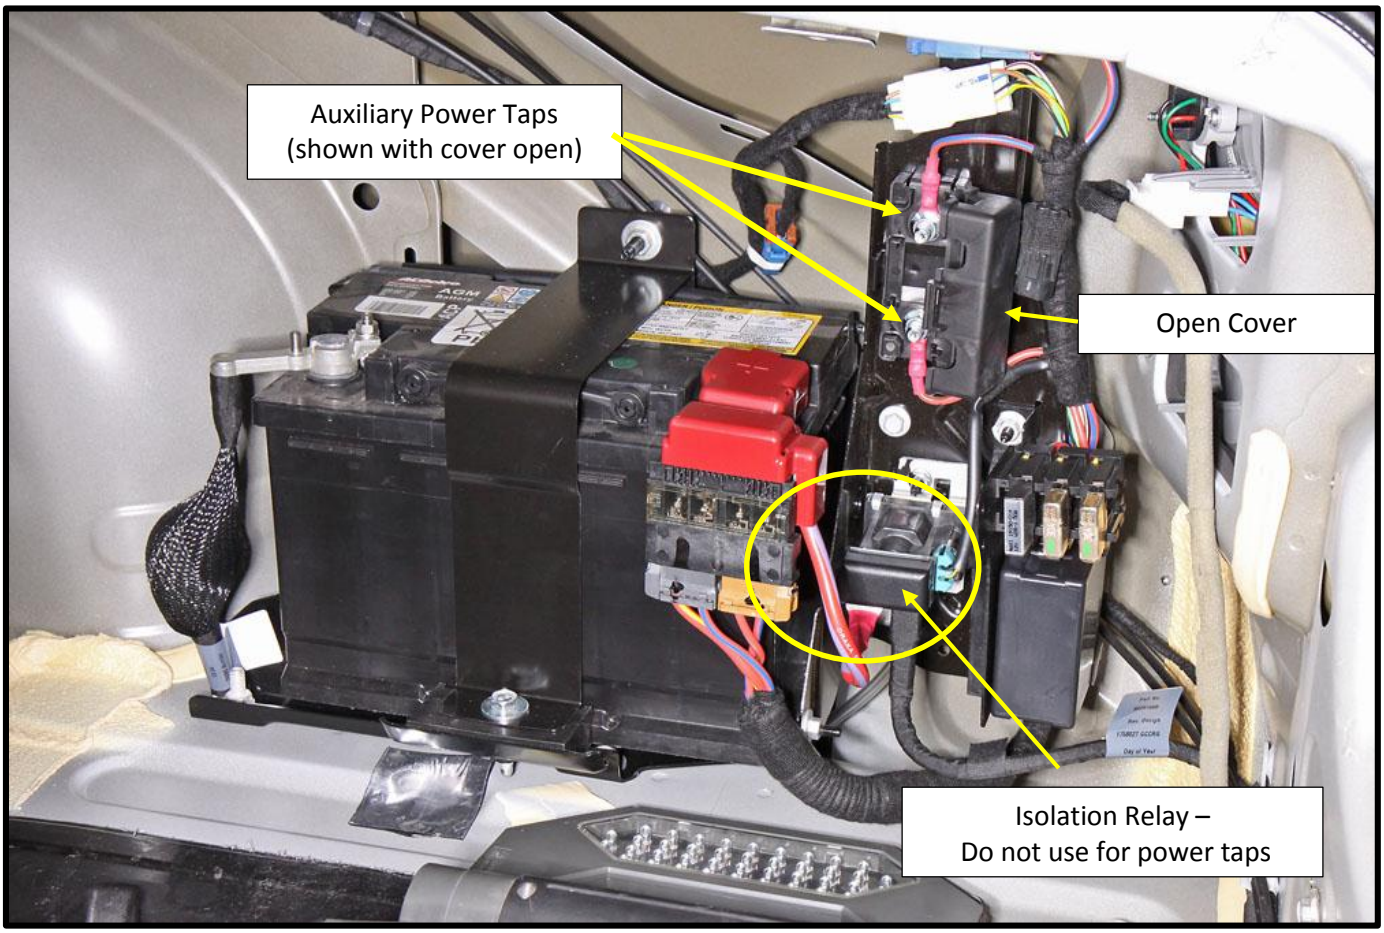
Improper electrical connections using the power studs on the Isolation Relay rather the provided power studs. Any added power circuit in the trunk electrical center should not utilize the studs on the isolation relay

The Caprice PPV equipped with the auxiliary battery (SEO K5S) utilizes an isolation relay to protect the auxiliary battery from being discharged during engine starting. To eliminate the possibility of improper power tapping refer to the image below to identify the location of the proper power taps on vehicles equipped with the auxiliary battery (SEO K5S) which is located in the trunk of the vehicle directly behind the RH wheel.
